**Equalize Air Installation and
Performance Report**

Brassii Restaurant, Toronto

Prepared for: Enbridge Gas Distribution

Date: February 8, 2005

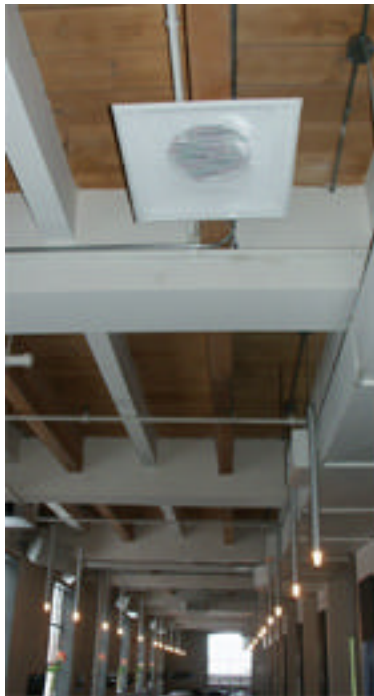
Figure 6 – Location of Equilize Air unit #1 in Brassaii

The horizontal positioning of the units had to take into account hot and cold spots in the restaurant and take in account that the vertical air flow does not interfere with the customers seating. The units were mounted as high as possible on the ceiling beams as illustrated in “Figure 6”.

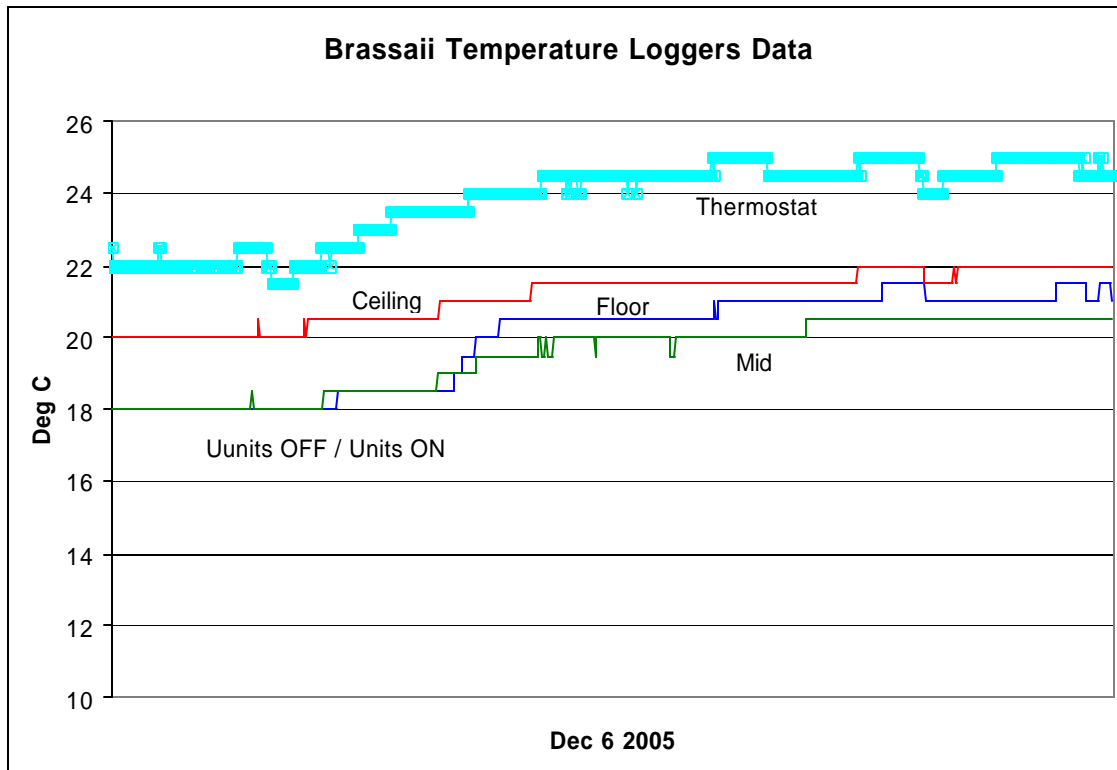
Figure 7

The data from the loggers clearly shows in “Figure 7” how the floor temperature rises and supersedes the mid level temperature once the units are turned on. Individual charts of the data loggers can be found in Appendix 1 to 4 to more clearly show the data from the loggers.

From the combined charts in “Figure 7” we can also see the effect of the overall temperature rise in the restaurant as a result of the horizontal equalization of the room. This effect is a result of the movement of the ceiling hot air located in the kitchen area near the thermostat with values above 25oC. (See thermograph of the kitchen area FLIR 4).

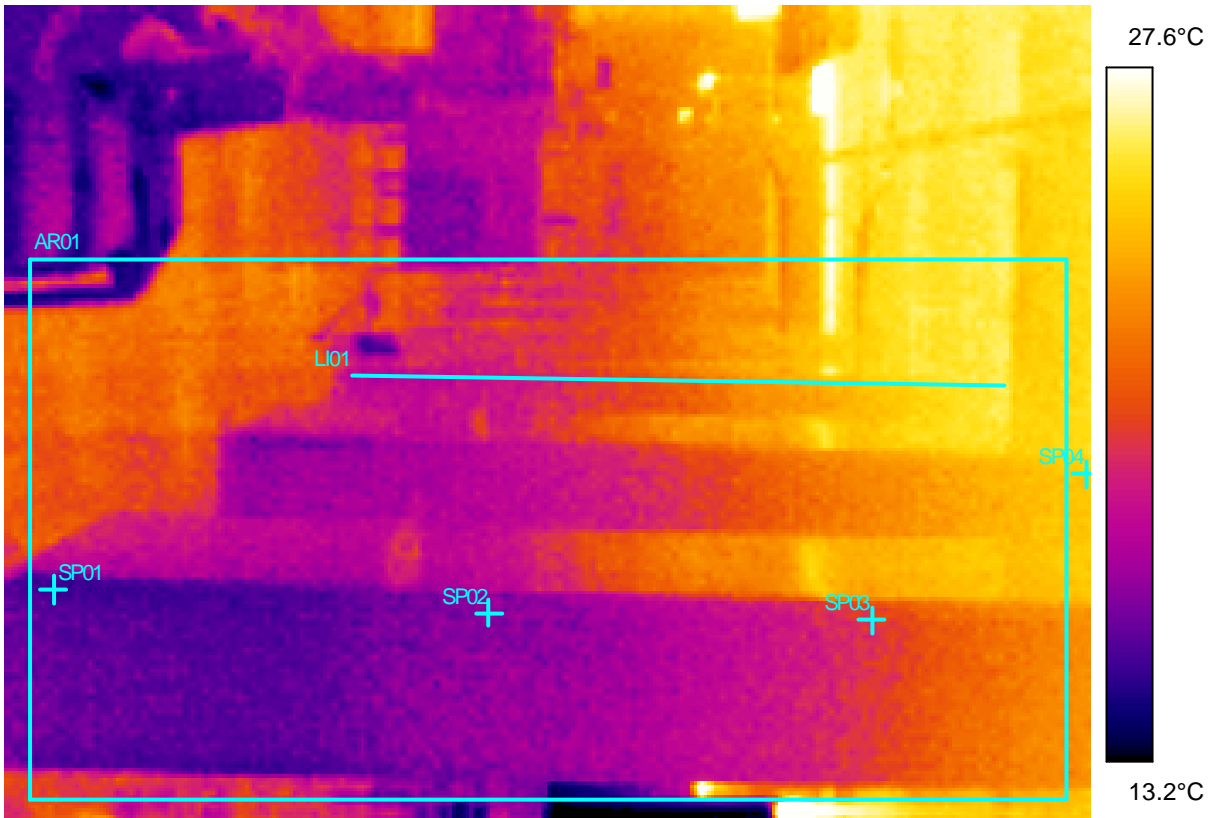
Brassaii Equailize Air Units OFF - Columns

IR information	Value	
Date of creation	1/5/2005	-
Time of creation	2:51:09 PM	-
Object parameter	Value	
Emissivity	0.94	-
Object distance	6.0 m	-
Ambient temperature	20.0°C	-
Atmospheric temperature	20.0°C	-
Transmission	0.99	-
Label	Value	Diff
SP01	17.7°C	-2.3°C
SP02	18.7°C	-1.3°C
SP03	19.9°C	-0.1°C
SP04	22.8°C	2.8°C
LI01 : max	24.0°C	4.0°C
LI01 : min	19.0°C	-1.0°C

Brassaii vertical temperature distribution - Columns

The above picture shows the temperature distribution without the equalize air units operating. A temperature difference of 5.1 degrees C is measured across the first column. Measurement points SP 1,2,3 and 4 show the temperature of the columns at the respective height.

Infrared measurement of the columns on Jan 5 with Equalize Air system turned off

Stratification is noticeable across the columns with measured ΔT on the first column of 5.1°C with ceiling temperature of 22.8°C and floor temperature of 17.7°C . Head level temperature is measured at 19.9°C .

Line LI01 shows the temperature under the ceiling near the kitchen in the middle of the dining room at 24°C showing hot spots created by the kitchen. The main exhaust air leaves from this area and we can assume that at this time the exhaust temperature is over 24°C .

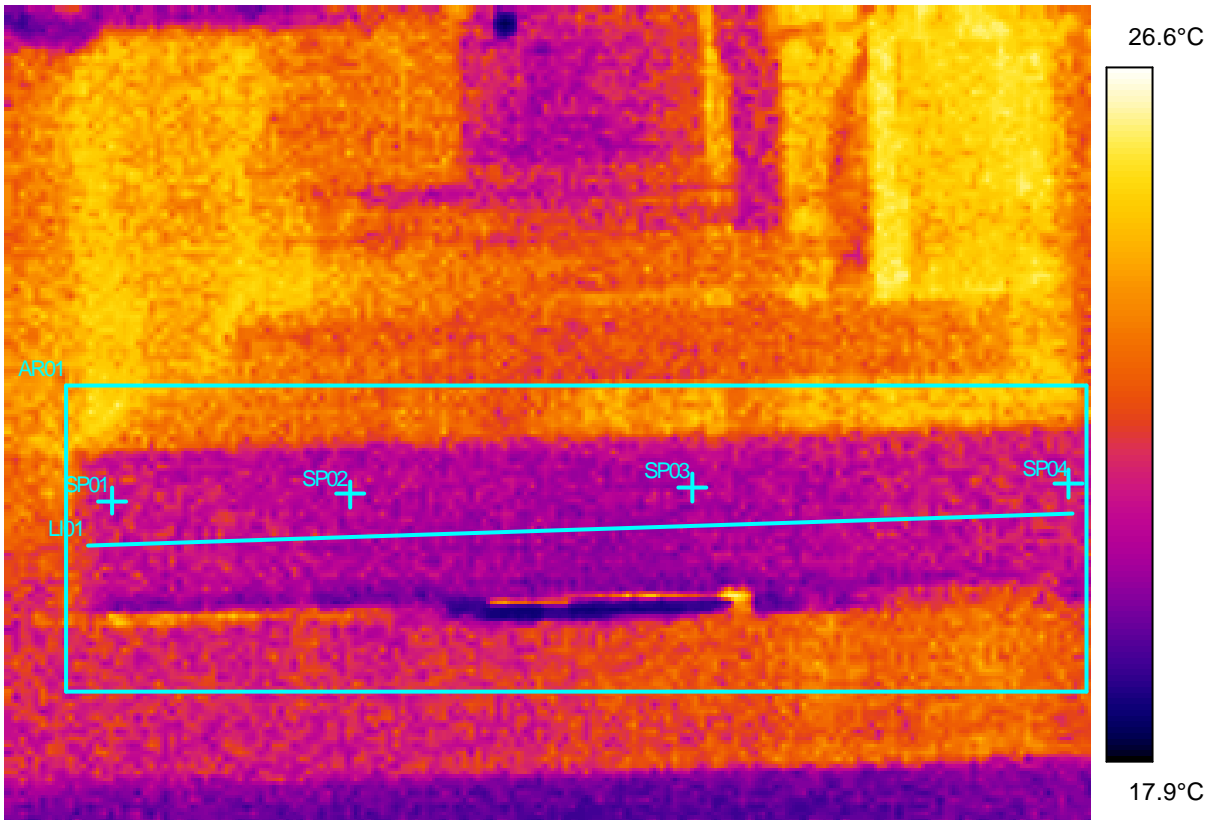
Brassaii Equailize Air Units ON - Columns

IR information	Value	
Date of creation	1/9/2005	-
Time of creation	2:55:24 PM	-
Object parameter	Value	
Emissivity	0.94	-
Object distance	2.0 m	-
Ambient temperature	22.0°C	-
Atmospheric temperature	22.0°C	-
Transmission	0.99	-
Label	Value	Diff
SP01	22.3°C	-0.1°C
SP02	22.3°C	-0.1°C
SP03	22.2°C	-0.2°C
SP04	22.3°C	-0.1°C
LI01 : max	22.5°C	0.1°C
LI01 : min	21.8°C	-0.6°C

Brassaii vertical temperature distribution - Columns

The above picture shows the temperature distribution in the main dining room of the restaurant. Measurement points SP 1,2,3 and 4 show the temperature of the columns at the respective height.

Infrared measurement of the columns on Jan 9 with Equalize Air system turned on

With the equalize air fans operating it is immediately noticed that there is almost no stratification. The temperature across the column is a steady 22.2°C . We can thus conclude that the equalize air fans brought the room temperature close to that of the ceiling. In this case the overall room temperature can be reduced with the thermostat setting at 20°C and thus generate substantial energy savings.

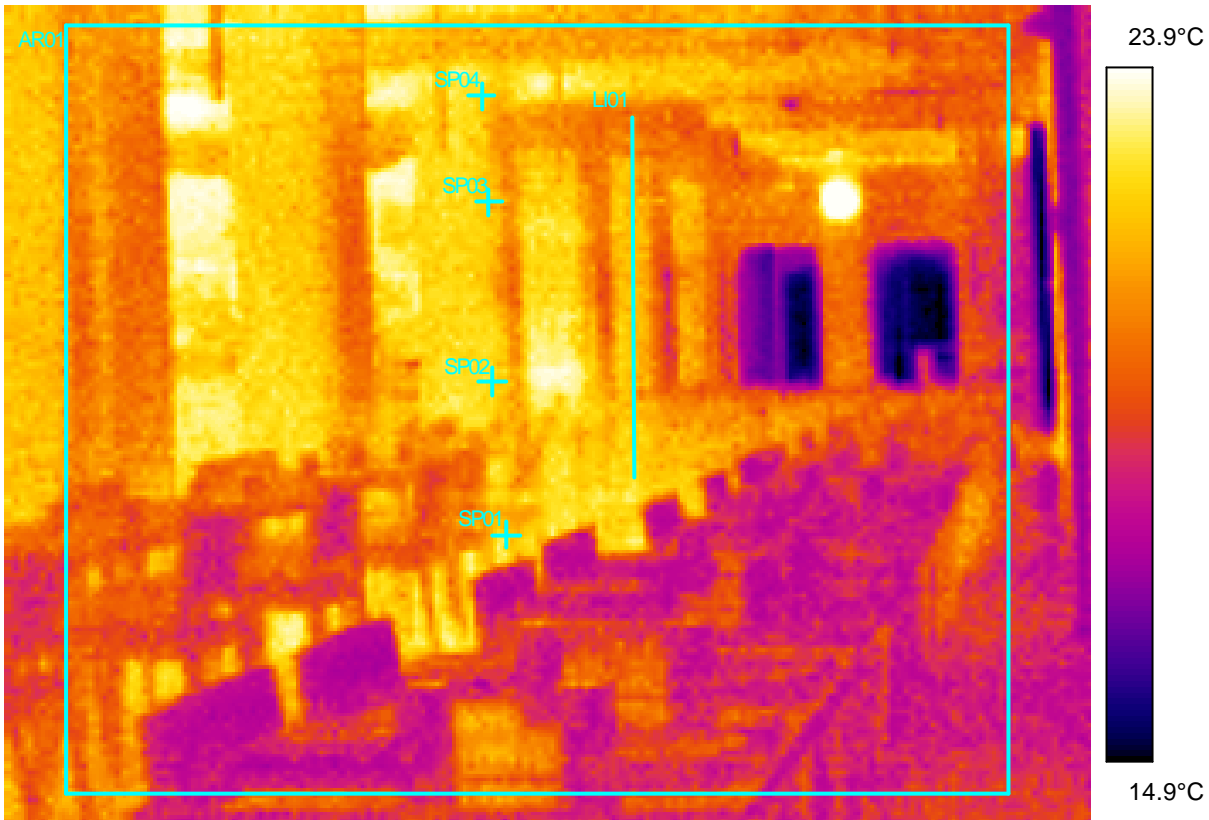
Brassaii Equailize Air Units ON - Room	9 jan 05
--	----------

IR information	Value	
Date of creation	1/9/2005	-
Time of creation	2:54:37 PM	-
Object parameter	Value	
Emissivity	0.94	-
Object distance	6.0 m	-
Ambient temperature	22.0°C	-
Atmospheric temperature	22.0°C	-
Transmission	0.99	-
Label	Value	Diff
SP01	22.5°C	0.1°C
SP02	22.4°C	0.0°C
SP03	22.2°C	-0.2°C
SP04	22.3°C	-0.1°C
LI01 : max	22.6°C	0.2°C
LI01 : min	21.5°C	-0.9°C

Brassaii vertical temperature distribution - Dining Room

The above picture shows the temperature distribution in the main dining room of the restaurant. Measurement points SP 1,2,3 and 4 show the temperature of the columns at the respective height.

Infrared measurement of the dining room on Jan 9 with Equalize Air system turned on

The infrared picture of the dining room shows how well the system equalized the temperature across the whole restaurant. Values of 22.4°C were found averaging across the room in both vertical and horizontal distribution.

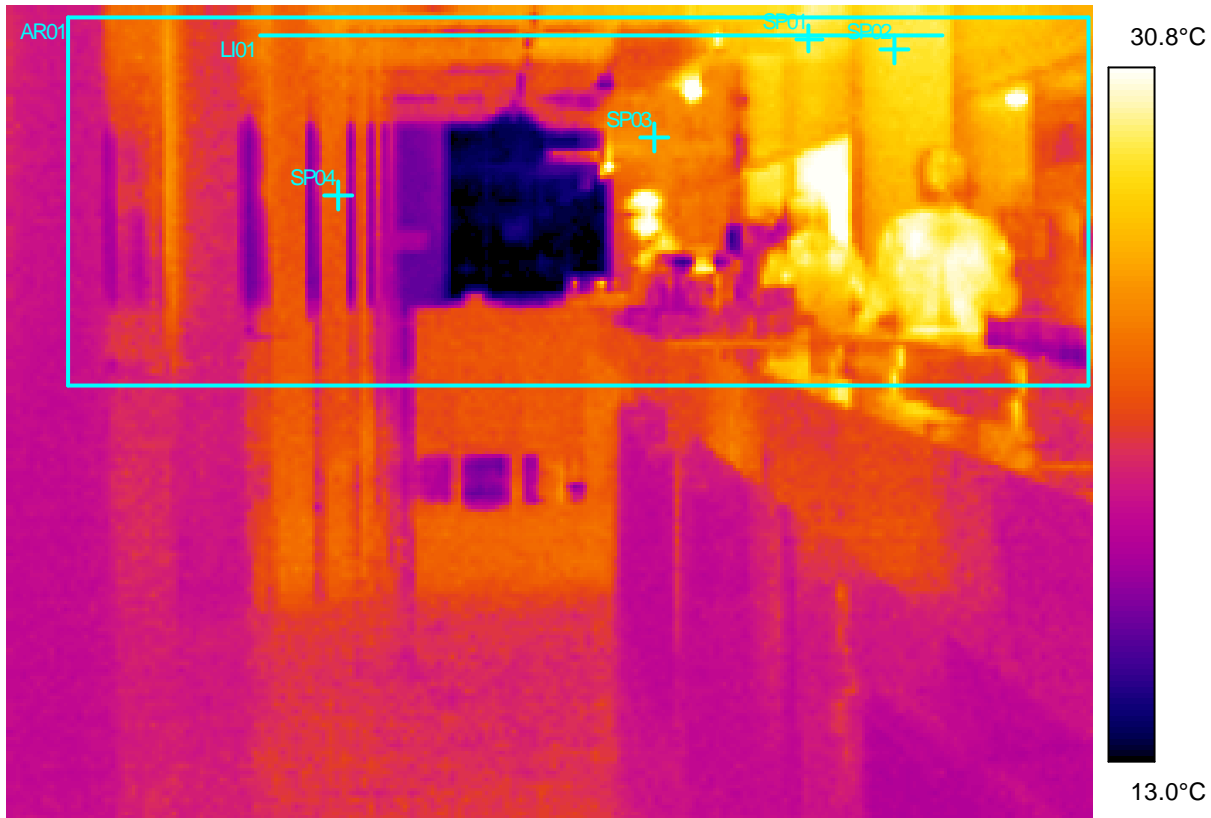
Brassaii Equailize Air Units OFF -Kitchen

IR information	Value	
Date of creation	1/7/2005	-
Time of creation	2:50:27 PM	-
Object parameter	Value	
Emissivity	0.94	-
Object distance	2.0 m	-
Ambient temperature	20.0°C	-
Atmospheric temperature	20.0°C	-
Transmission	0.99	-
Label	Value	Diff
SP01	28.4°C	8.4°C
SP02	28.0°C	8.0°C
SP03	25.2°C	5.2°C
SP04	24.3°C	4.3°C
LI01 : max	28.9°C	8.9°C
LI01 : min	23.5°C	3.5°C

Brassaii kitchen area teperature distribution

The above picture shows the temperature distribution in the area surrounding the kitchen. Measurement points SP 1,2,3 and 4 show the temperature at the respective locations while line 01 shows the minimum and maximum across the line distance..

Infrared measurement of the kitchen surroundings on Jan 7 with Equalize Air system turned off

The infrared picture of the bar and kitchen surrounding area that supplies exhaust air shows that the temperatures near the ceiling rise to 28°C . This is a major parameter in the heat loss and the picture confirms the isotherms illustrated in "Figure 5".

Since the isotherms around the kitchen at height of 1.8 m. show temperatures ranging from 25 ° C to 28 ° C (FLIR 4), we can assume a possible average reduction of 4 ° C when the kitchen operates. Unfortunately the kitchen does not operate full time so during idle hours the ?T

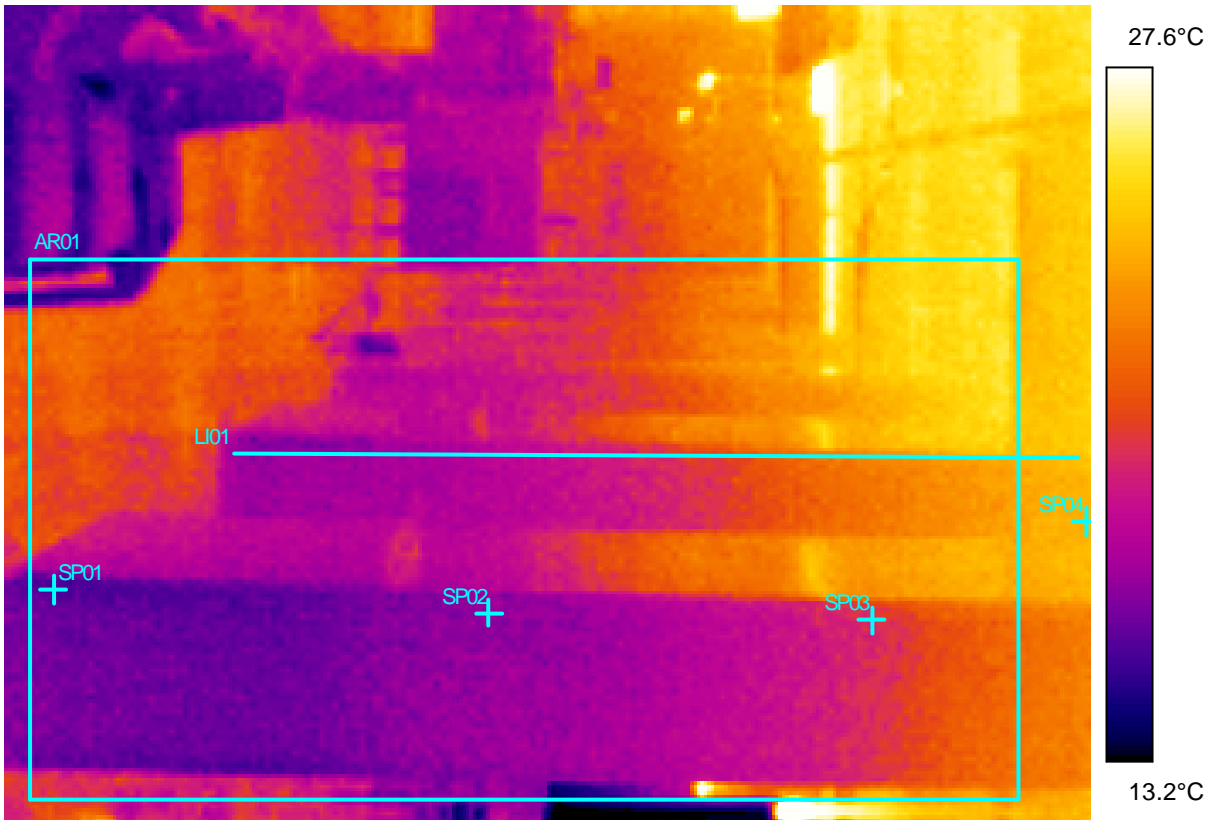
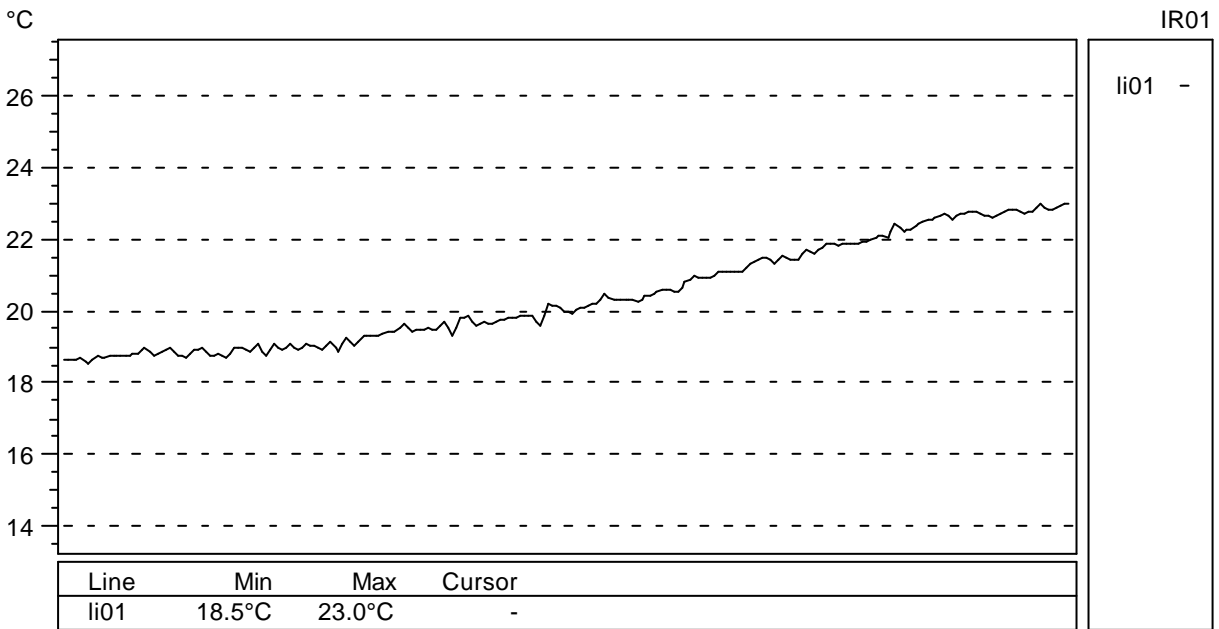
Equalize Air Units OFF - Column Temperature Graph

FLIR GRAPH 1 created by the infrared thermograph FLIR 1 shows the temperature difference and stratification across line LIO in the pictures to be 4.5°C .

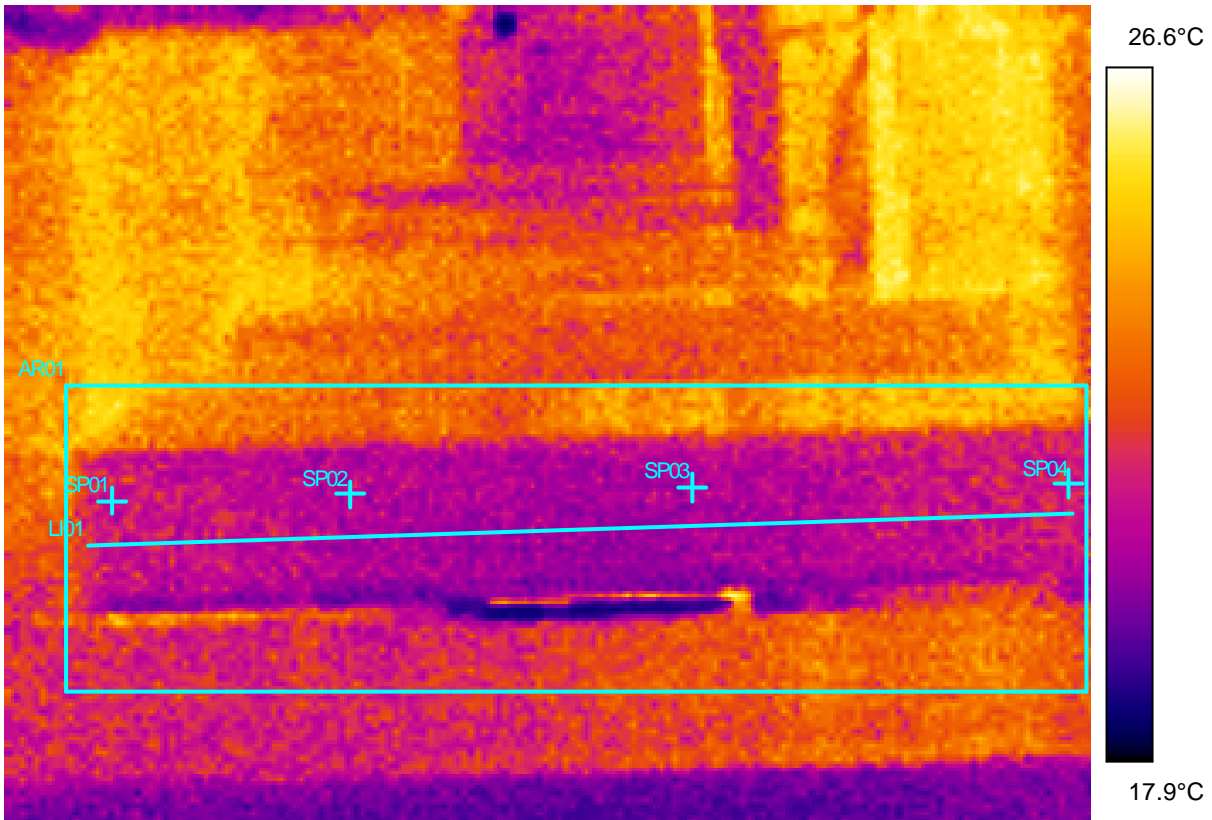
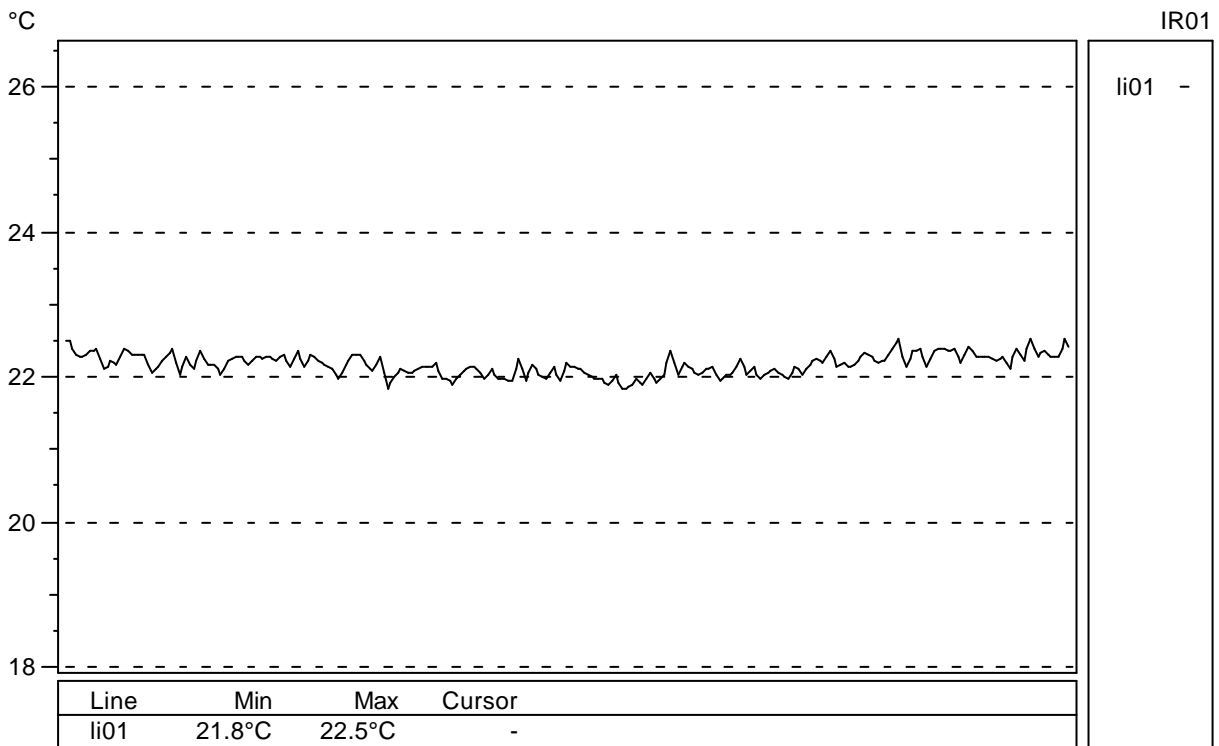
Brassaii Equailize Air Units ON - Column Graph

FLIR GRAPH 2 created by the infrared thermograph FLIR 2 shows the temperature difference and stratification across line LIO in the pictures to be 0°C .

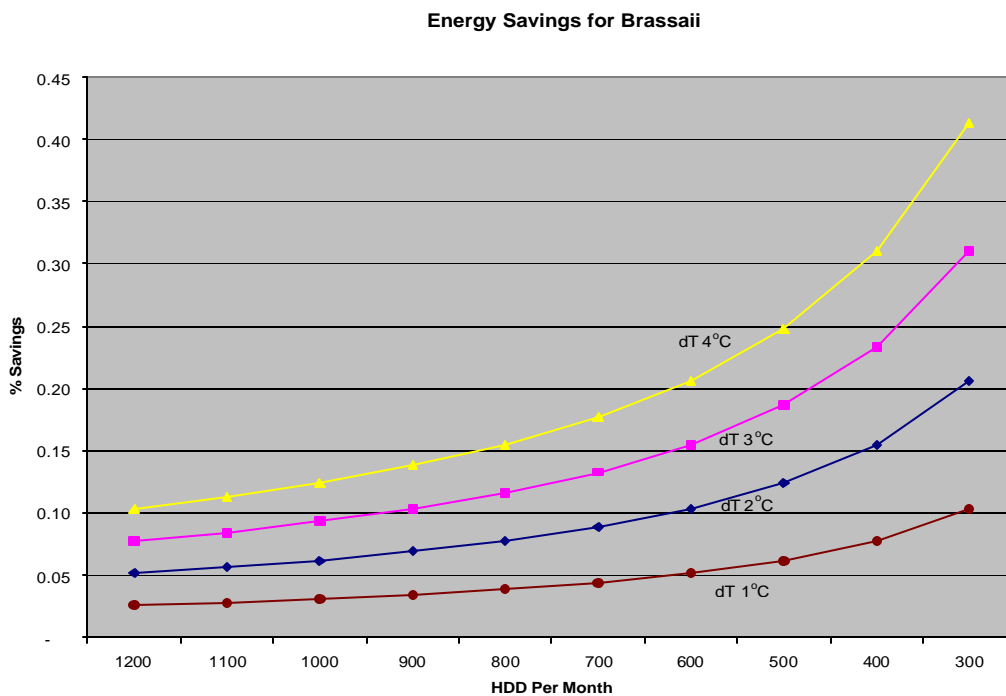
”Figure 6”

In order to analyze the savings we calculated the total gas consumption for the period Nov 28, 2003 to Jan 30 2004 and Nov 29, 2004 to Jan 31 2005 and compared it to the HDD for the respective periods excluding the average gas consumption during the summer periods for cooking calculated at 3062 m3. (“Figure 4” – Months: July, August and September of 2004).

Gas consumption for heating was calculated at 1347 m3 for 1410 HDD and 974 m3 for 1413 HDD respectively. This shows a savings of 28% for the period that used the Equalize air units. Since most of the gas was consumed in the kitchen for cooking, its effect in the total gas consumption can not be easily separated without additional monitoring. Brassaii also intermittently operated gas patio heaters during the month of November and this consumption needs to be taken into account. Nevertheless the number of 28% gas consumption for heating warrants additional testing and measurements.

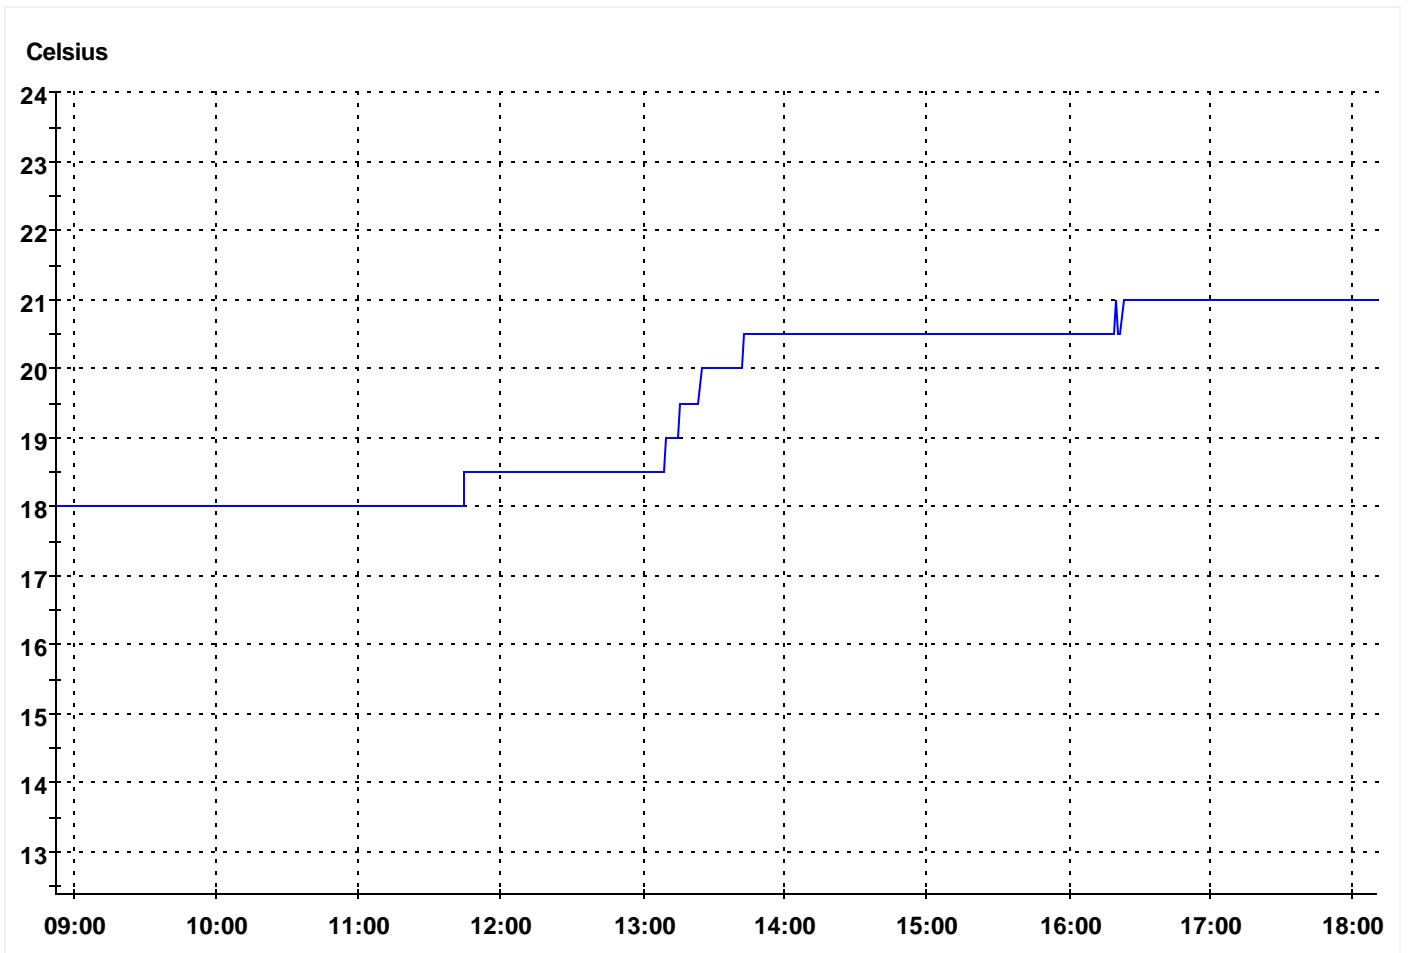
Brassai Floor

From:- 06 January 2005 08:52:00 To:- 06 January 2005 18:10:00

1. The location of the first unit designated “Brassaii floor” was 15 cm above floor level at the first column under the equalize air unit next to the entrance. Chart 1 illustrates the temperature data of this unit.
2. The second unit designated “Brassaii Mid” was located at a height of 1.5 meters on the first indoor column. Chart 2 illustrates the temperature data of this unit.
3. The third unit designated “Brassaii Ceil” was mounted 10 cm below the ceiling above logger Brassaii Mid.
4. The Fourth unit designated “Brassaii Therm” was mounted in the thermostat housing and its function was to measure the

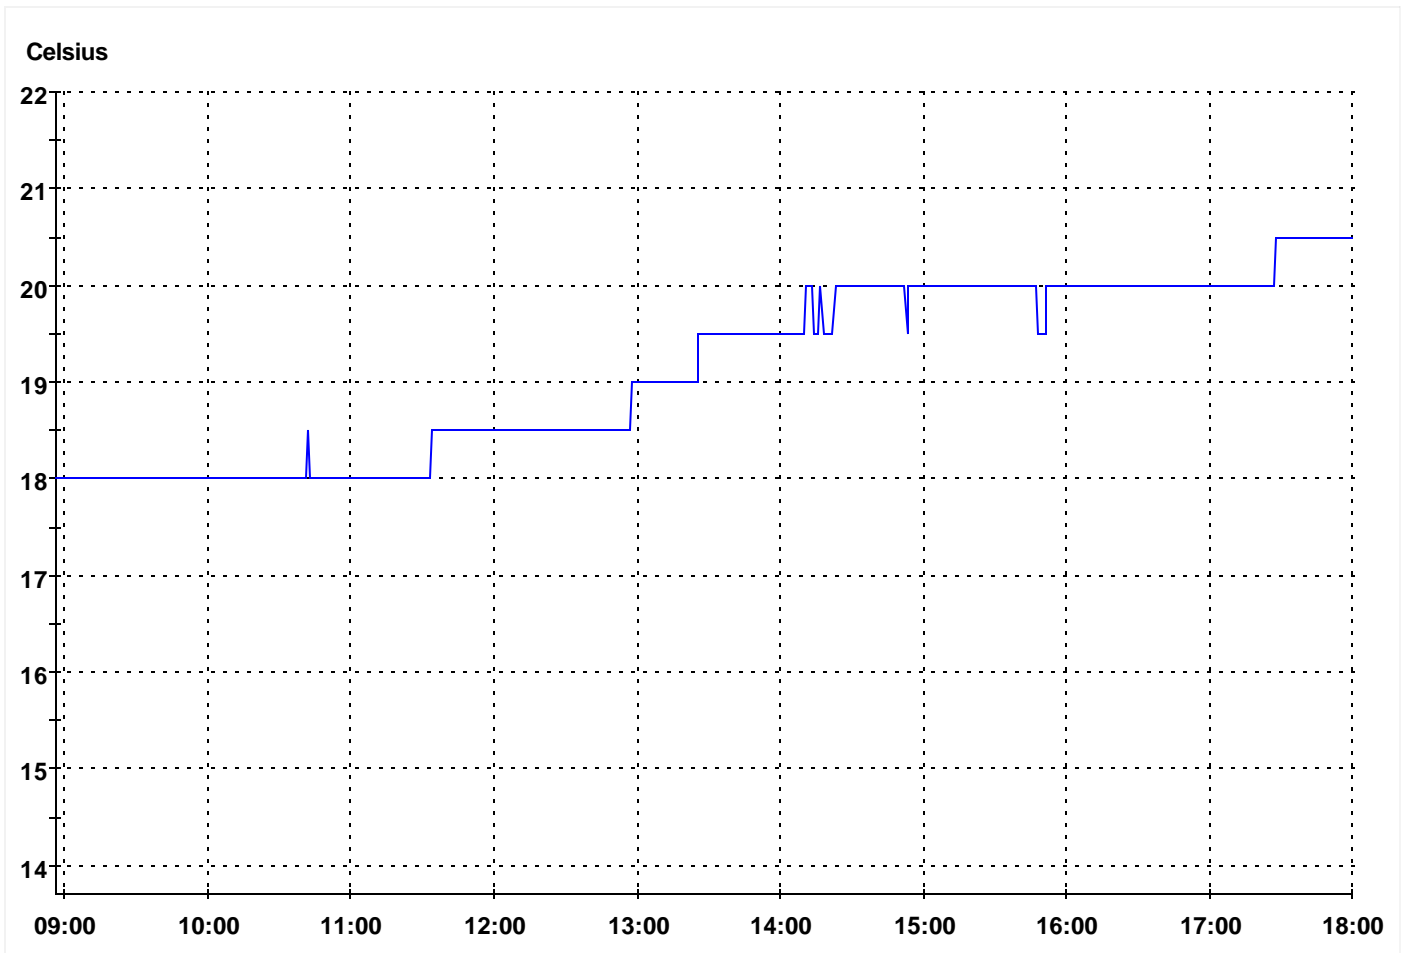
Brasai Mid

From:- 06 January 2005 08:56:00 To:- 06 January 2005 18:00:00

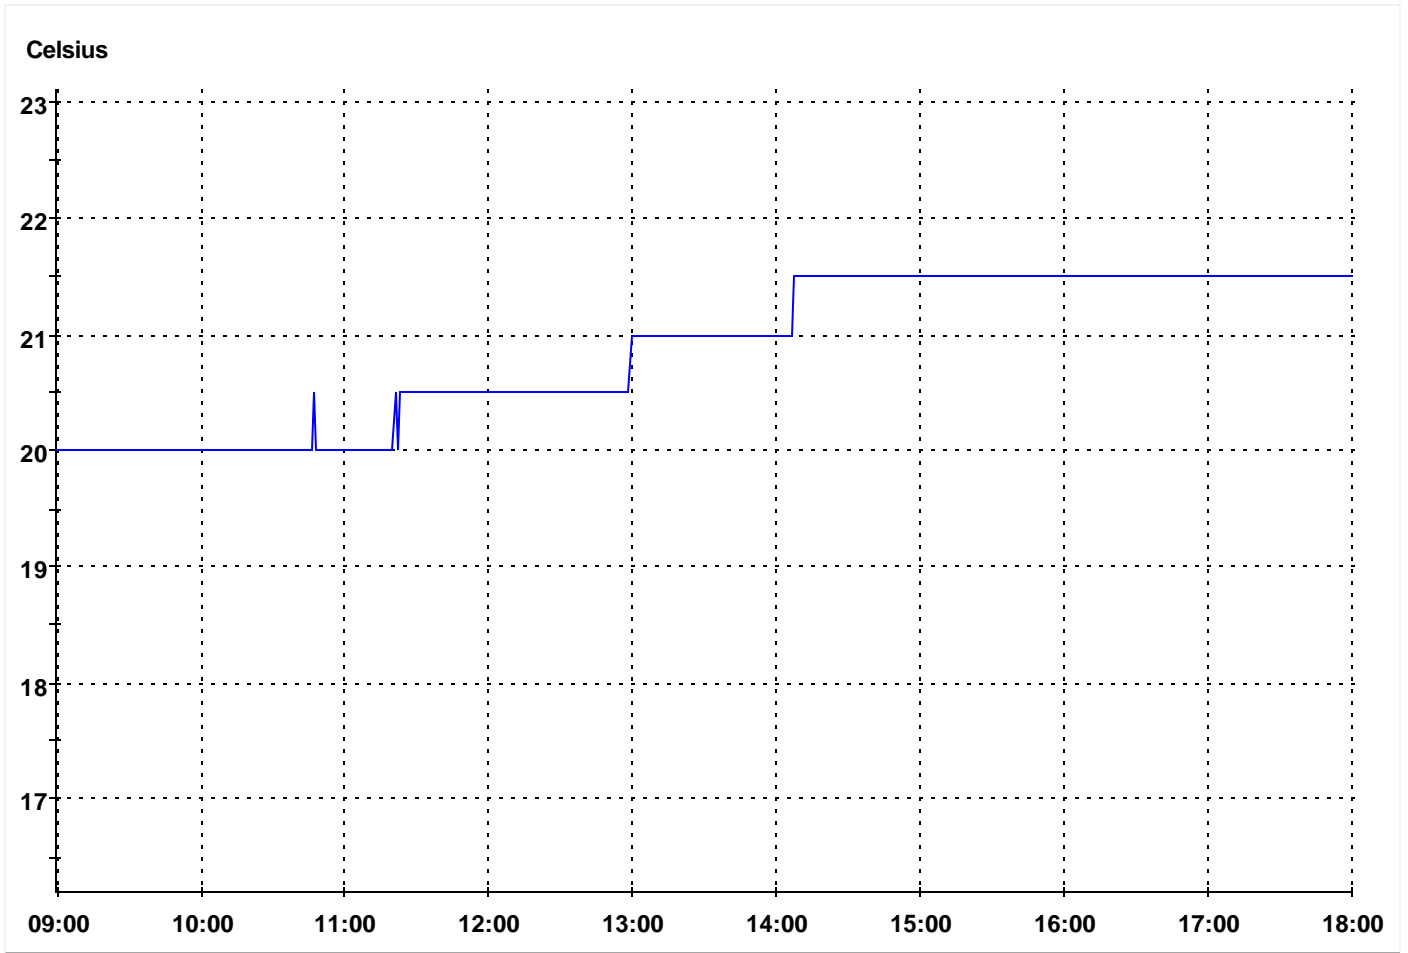
Brasai Ceil

From:- 06 January 2005 08:59:00 To:- 06 January 2005 18:00:00

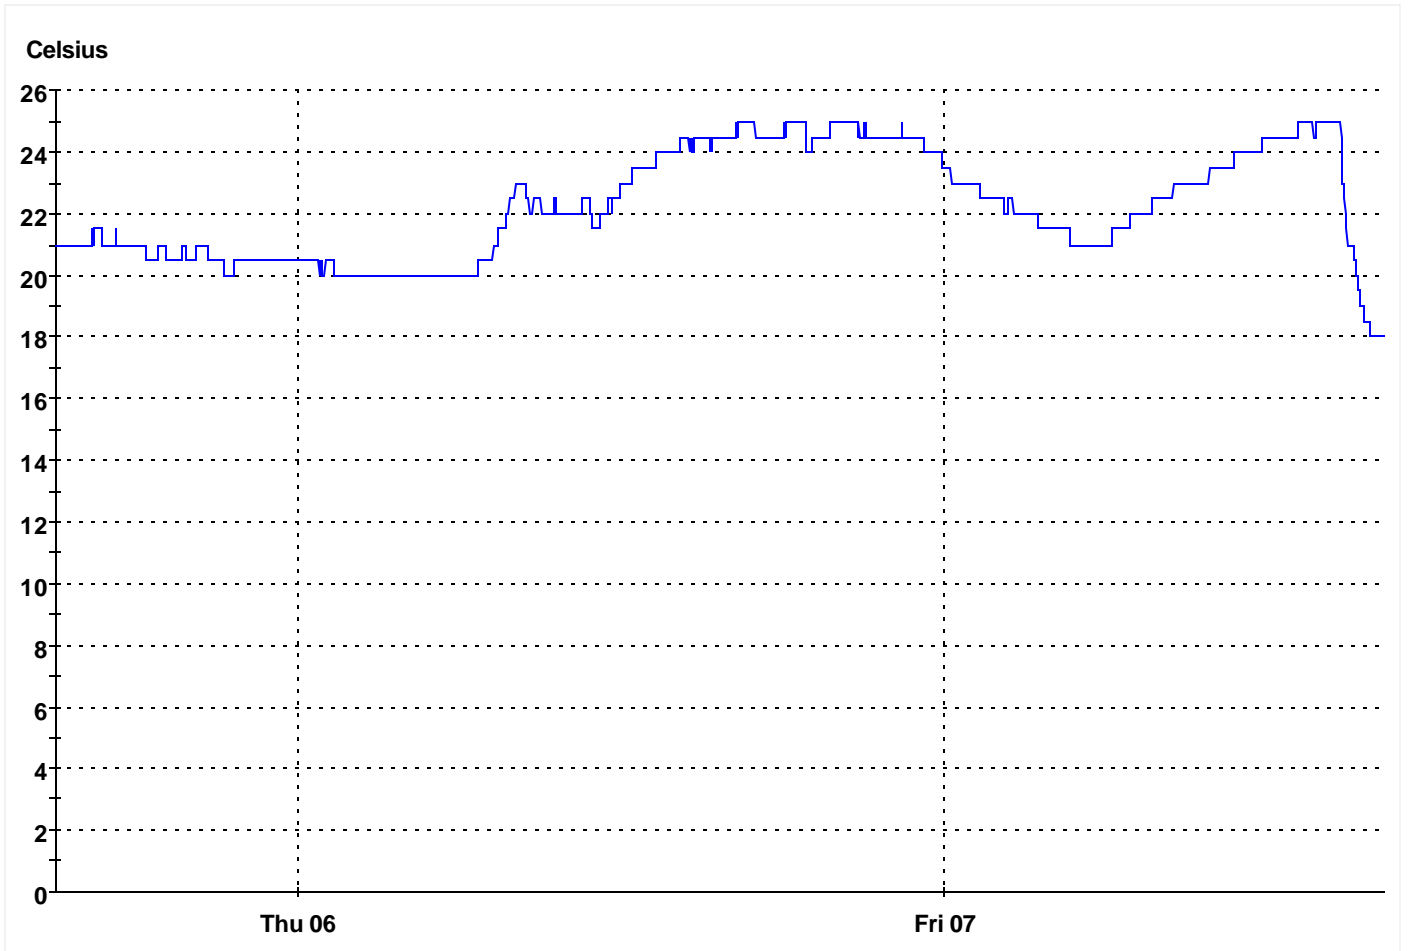
Brasai Therm

From:- 05 January 2005 15:00:00 To:- 07 January 2005 16:20:00

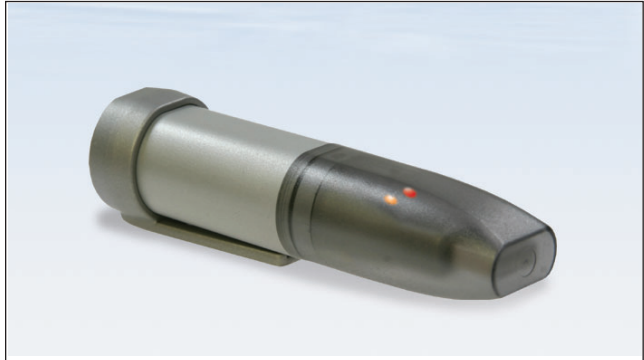
Temperature Data Logger with USB Interface

This data logger measures and stores up to 16,382 temperature readings over a -25 to +80°C (-13 to +176°F) range. The user can easily set up the logging rate and start-time, and download the stored data by plugging the module straight into a PC's USB port and running the purpose designed software under Windows 98, 2000 or XP. Data can then be graphed, printed and exported to other applications. The data logger is supplied complete with a long-life lithium battery, which will last for at least 1 year. Correct functioning of the unit is indicated by a flashing red, green and orange LEDs. The data logger is protected against moisture to IP 67 standard when the protective cap is fitted.

For the purpose of measuring the temperature at Brassaii four data loggers were installed along one pillar. These data loggers model EL-USB-1 were set to measure temperature every 1 minute. Specifications of this Unit can be seen in Appendix 6.
