**Equalize Air Inspection Report
Canadian Tire
Peterborough Store**

Prepared for: Enbridge Gas Distribution

Date: February 9, 2005

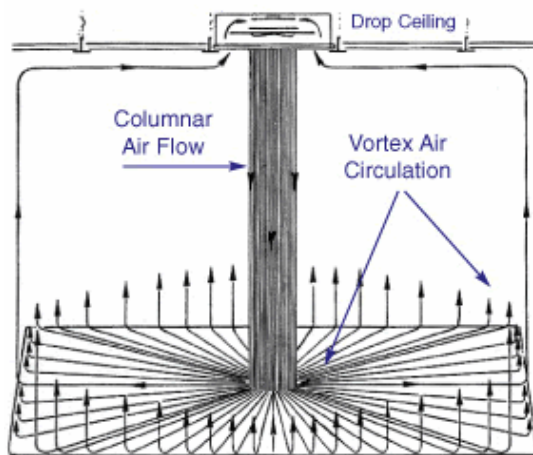
Figure 1 (a) Equalize-Air System unit
<http://www.equalize-air.com/howitworks.html>

The Equalize-Air ceiling fans (equalizer units) are composed of a special air-circulating fan with a patented method of collecting warm air beneath the ceiling or roof. The device returns the warm air to the floor through a narrow columnar air path, as seen in “Figure 1” (a).

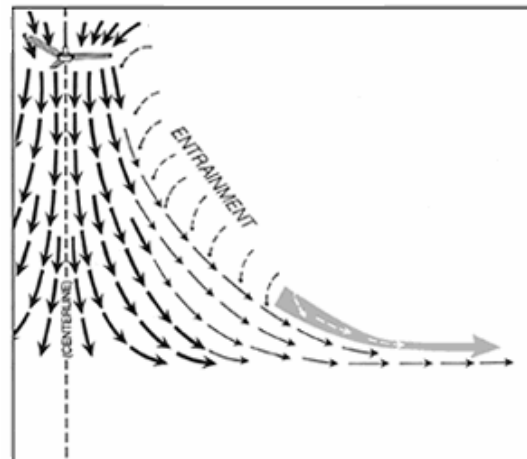
Figure 1 (b) conventional ceiling fan unit

The fan has a specially designed blade with a ventral ring to collect the warm air and using the grate to channel the air straight down in a column rather than dispersing the air like a conventional industrial ceiling fan, as seen in “Figure 1” (b).

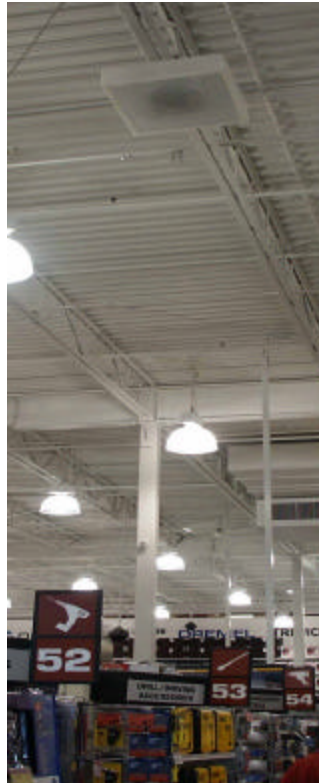
Figure 6 – Location of Equalize Air unit #1 in Canadian Tire Store

The horizontal positioning of the units had to take into account the location of the isles and the air flow. The units were mounted as high as possible on the ceiling as illustrated in “Figure 6”.

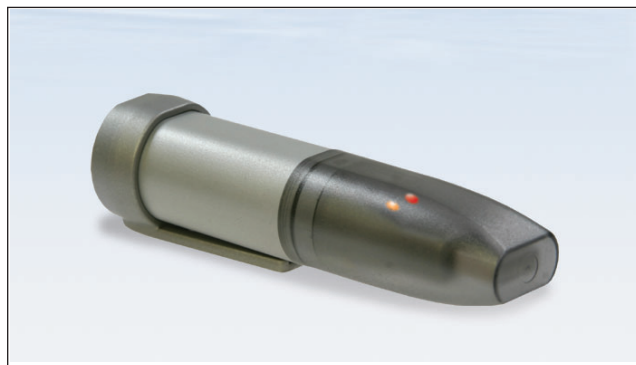
This data logger measures and stores up to 16,382 temperature readings over a -25 to +80°C (-13 to +176°F) range. The user can easily set up the logging rate and start-time, and download the stored data by plugging the module straight into a PC's USB port and running the purpose designed software under Windows 98, 2000 or XP. Data can then be graphed, printed and exported to other applications. The data logger is supplied complete with a long-life lithium battery, which will last for at least 1 year. Correct functioning of the unit is indicated by a flashing red, green and orange LEDs. The data logger is protected against moisture to IP 67 standard when the protective cap is fitted.

- -25 to +80°C (-13 to +176°F) Measurement Range
- USB Interface for Set-up and Data Download
- 2 User-Programmable Alarm Thresholds
- Bright Red, Green and Orange LED Indication
- Replaceable Internal Lithium Battery
- IP 67 Protection
